⁽⁶⁾
METALLURGICAL CHANGES IN THE HIGH
TEMPERATURE FRETTING OF Ni and Ti
ALLOYS

⁽⁹⁾ Final Technical Report

⁽¹⁰⁾ R.B. Waterhouse and M.M. Hamdy

⁽¹¹⁾ February 1979

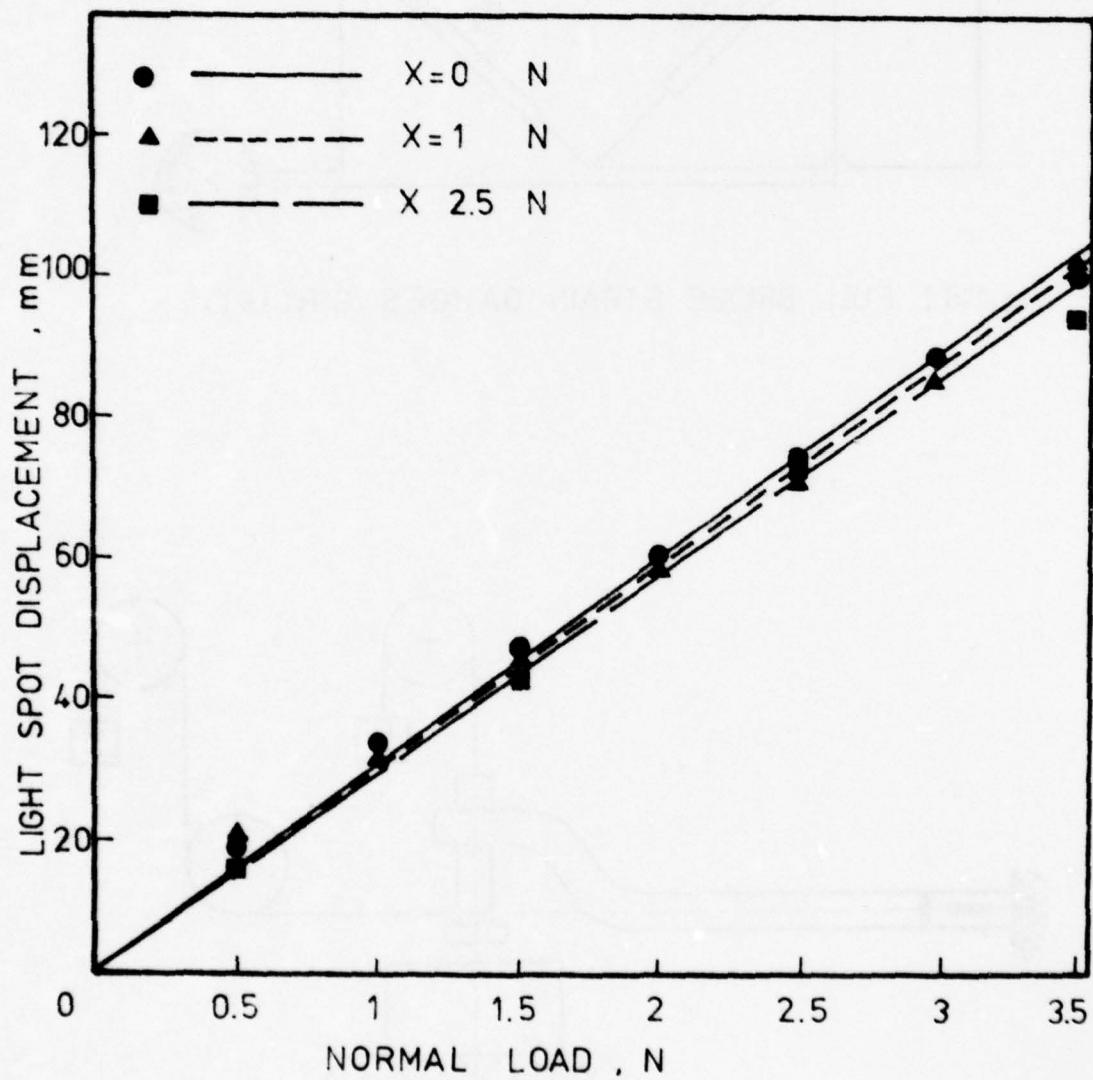
Fig. (20) CALIBRATION RESULTS OF NORMAL FORCE.

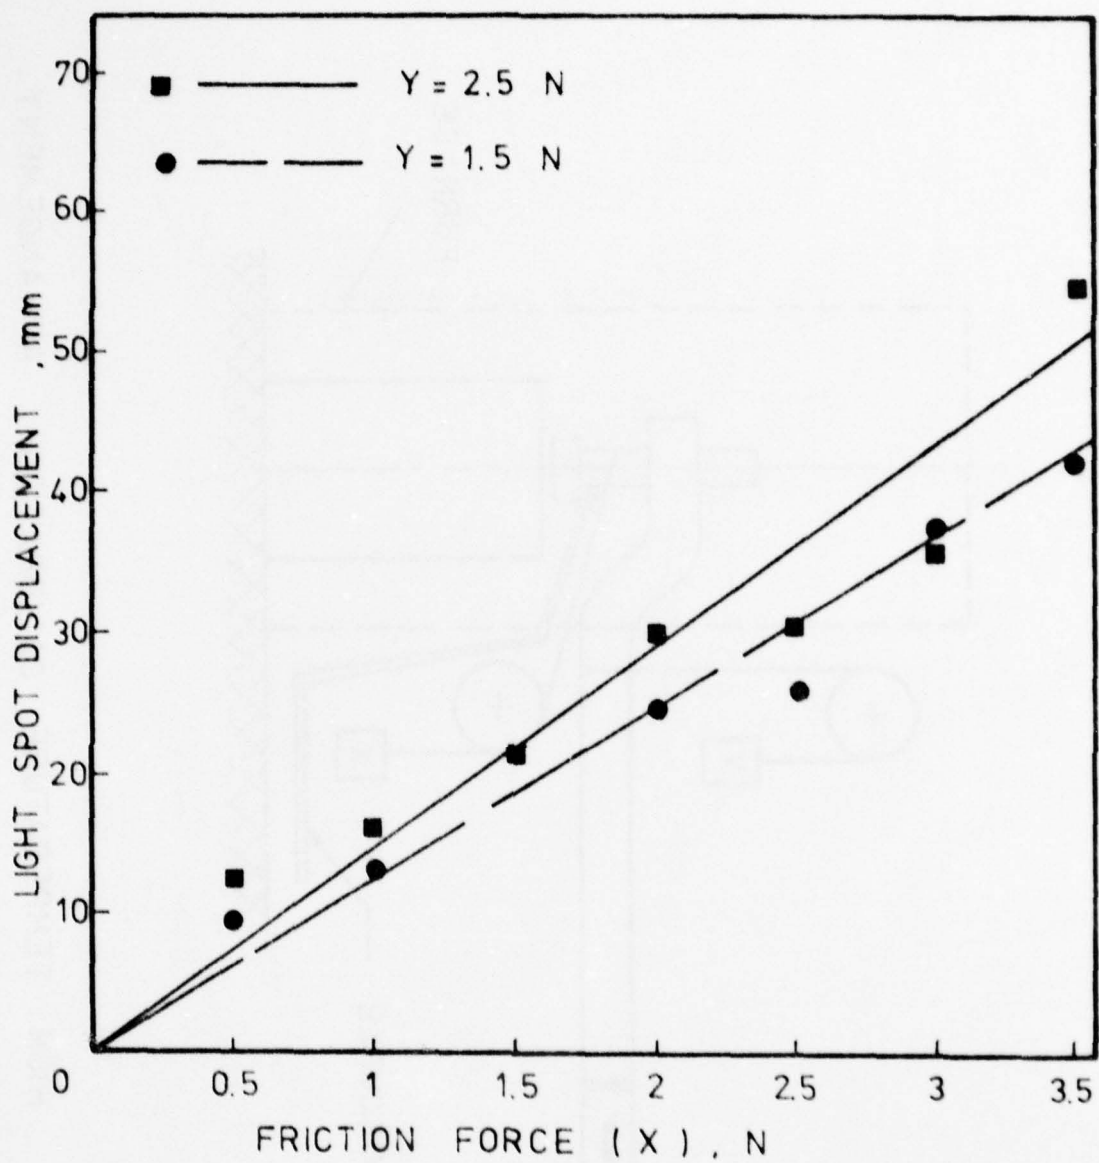
Fig. (21) CALIBRATION RESULTS OF THE FRICTION FORCE.

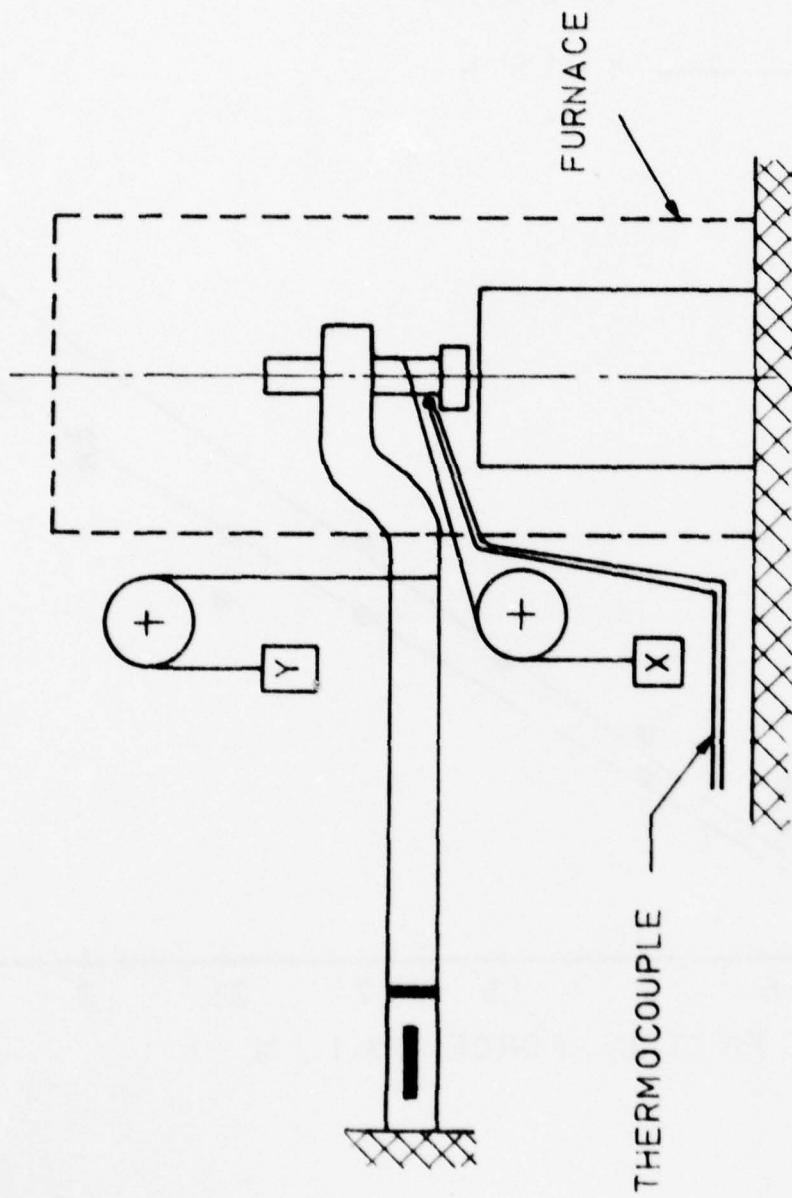
Fig. (22) HIGH TEMPERATURE CALIBRATION ARRANGEMENT .

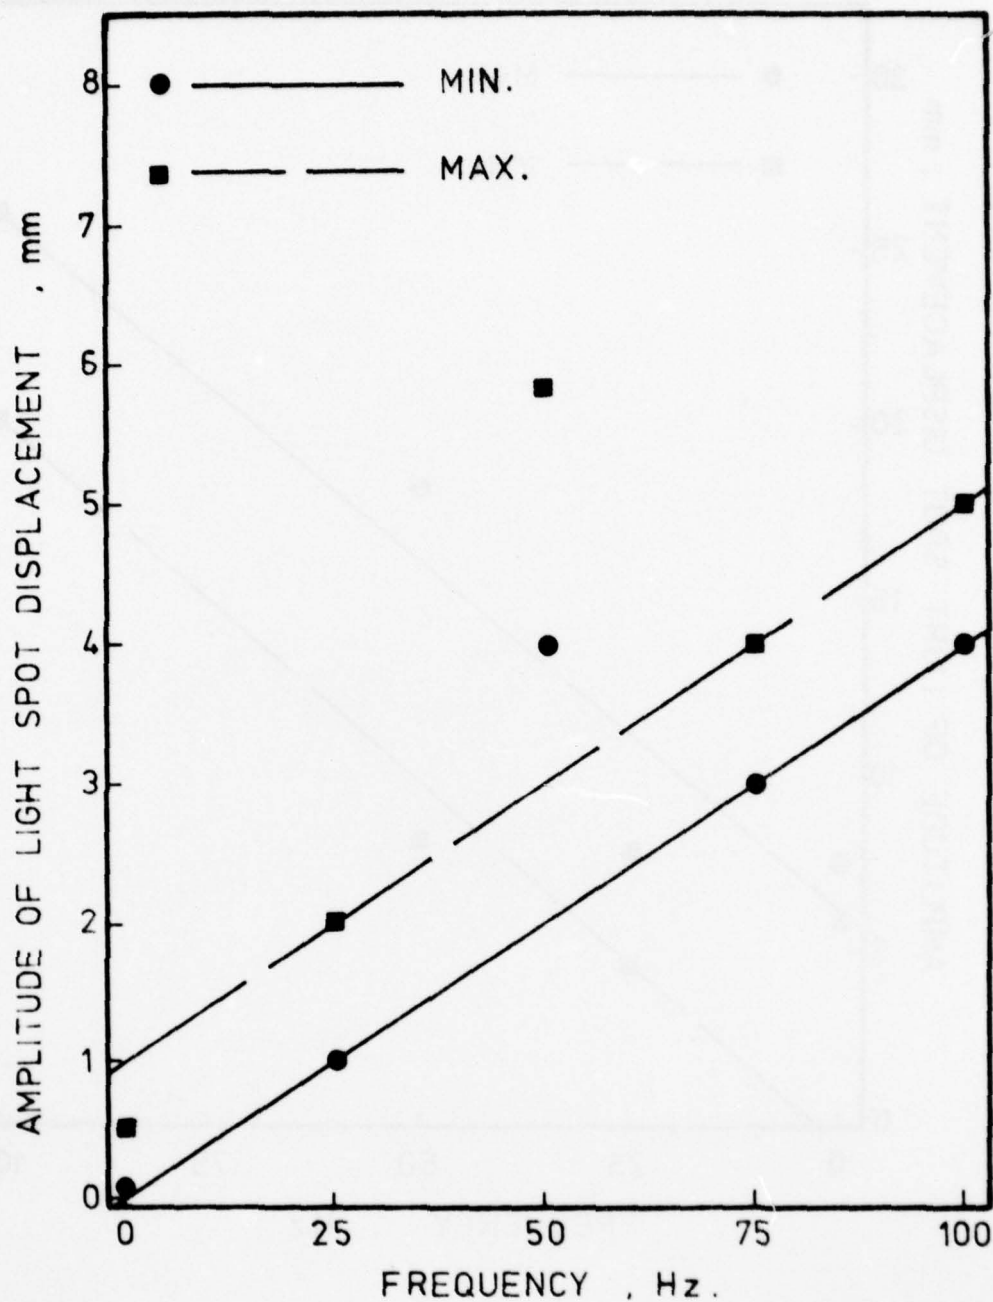
Fig. (23) THE RECORDED SIGNAL PRODUCED BY THE INERTIA FORCE IN THE NORMAL FORCE MEASURING ARRANGEMENT AT $40\mu\text{m}$ SLIP .

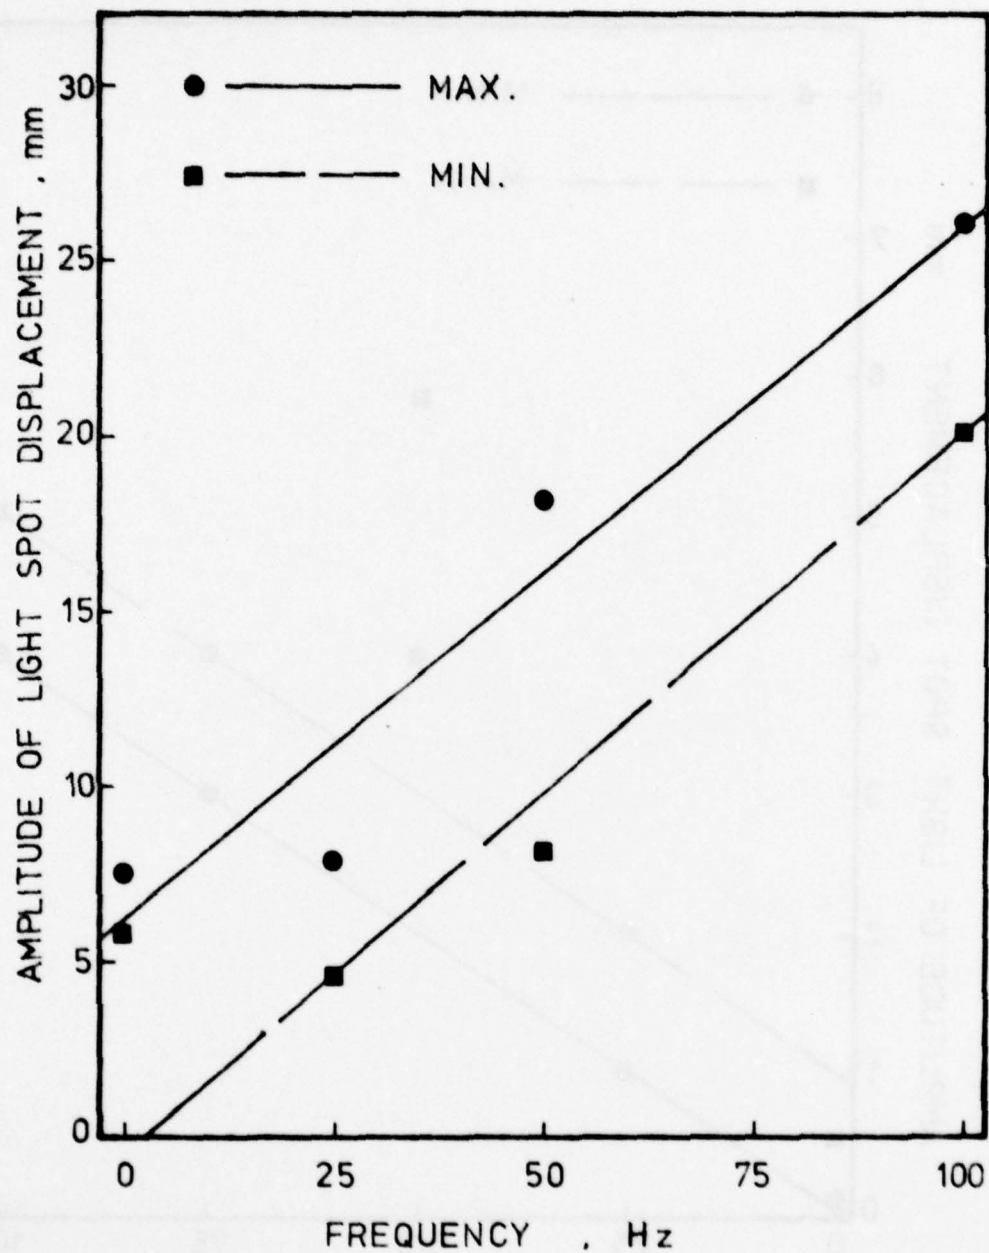
Fig. (24) THE RECORDED SIGNAL PRODUCED BY THE INERTIA FORCE IN THE FRICTION FORCE MEASURING ARRANGEMENT AT 2.5 N NORMAL FORCE AND 40 μ m SLIP.

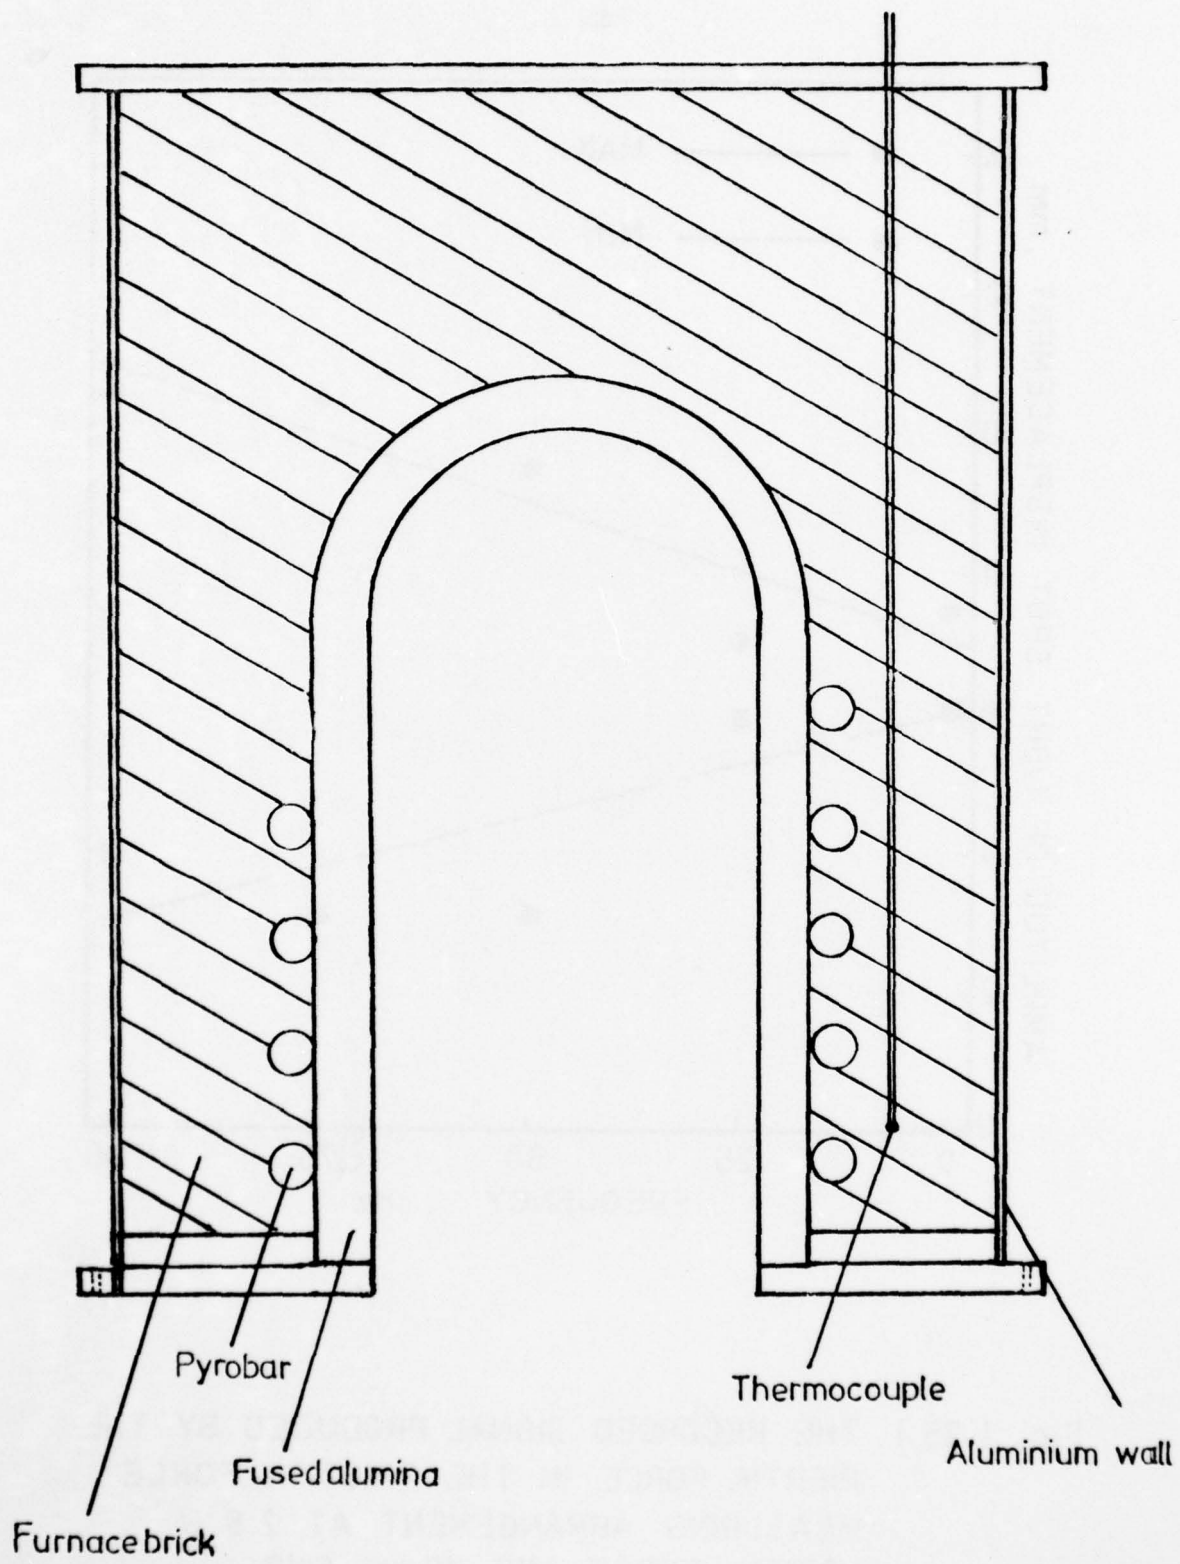
Fig. (26) THE FRETTING WEAR FURNACE .

A furnace previously constructed by Overs (7) was used to surround the rider and the flat specimen during the high temperature fretting wear tests. The furnace was a vertical shaft type one closed from the top side as shown graphically in Figure 26. A slit was cut into the furnace wall to accommodate the transmission shaft. Alumina cement was used to face the sides of this slit and a coating of sodium silicate sealed the pores in the cement preventing any contamination from dust particles. The inside of the furnace was dome-shaped and constructed from a fused alumina tube. This provided an excellent dust-free enclave. A heating element (Pyrobar) of 3 kW capacity was wound around the dome. The outer wall of the furnace was constructed from aluminium sheet while the top and bottom sides of it were closed by sindanyo heat insulating material. The inner space between the dome and the outer surface was filled with heat insulating wool (Triton Kao wool ceramic fibre).

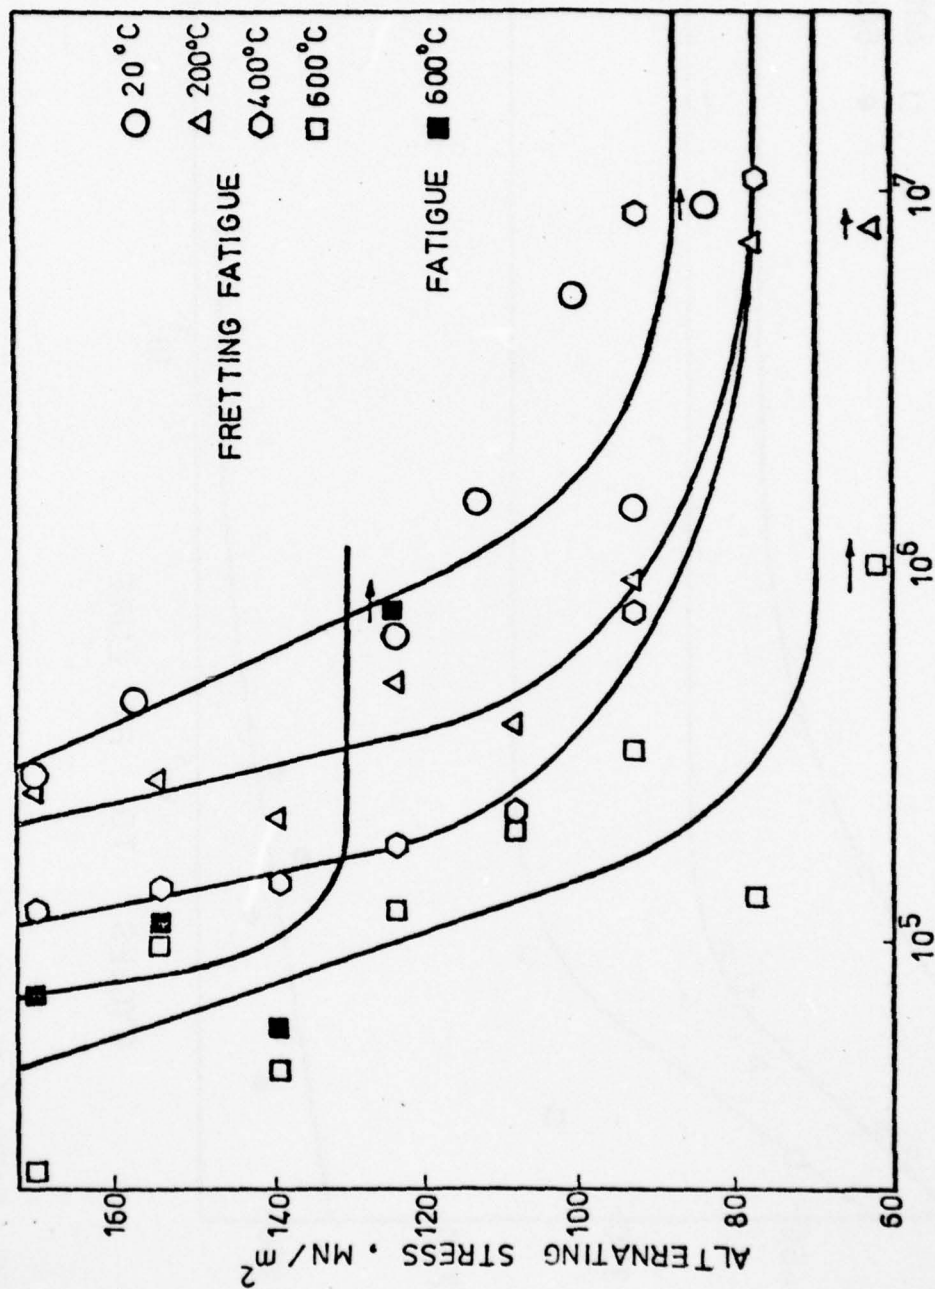
Fig. (27) FRETTING FATIGUE CURVES FOR TI-ALLOY (IMI 318)

The two specimens which were tested at 200 C with alternating stresses more than 140 MN/m² have more cycles to failure than expected. This is due to the gross slippage which occurred in the first few cycles as shown in Plate 10.

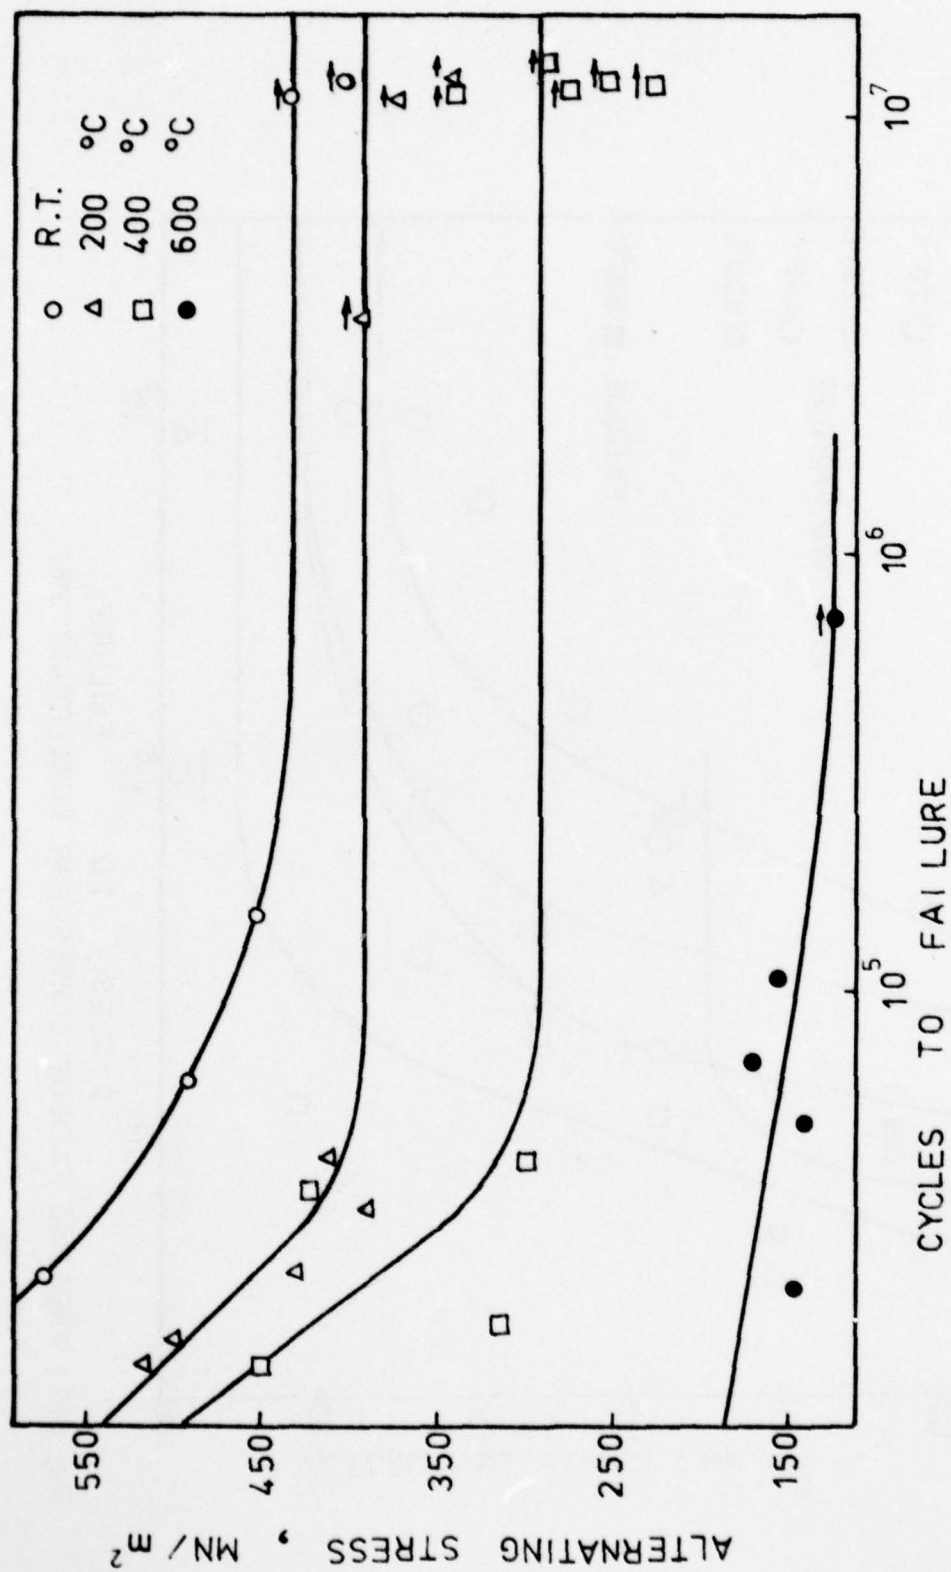
FIG. 28 FATIGUE CURVES OF ANNEALED TI-6AL-4V (IMI 318), MEAN STRESS=247 MN/m².

Ti-6Al-4V (IMI 318) specimens in the mill annealed condition were tested in the absence of fretting at room temperature, 200, 400 and 600 C. Unfortunately, it was found impossible to obtain plain fatigue curves at any of the temperatures below 600 C at the same mean stress used in the fretting fatigue tests, i.e. 247 MN/m². For this reason the mean stress was increased as the test temperature decreased to enable plain fatigue curves to be obtained. The results are shown in the table below.

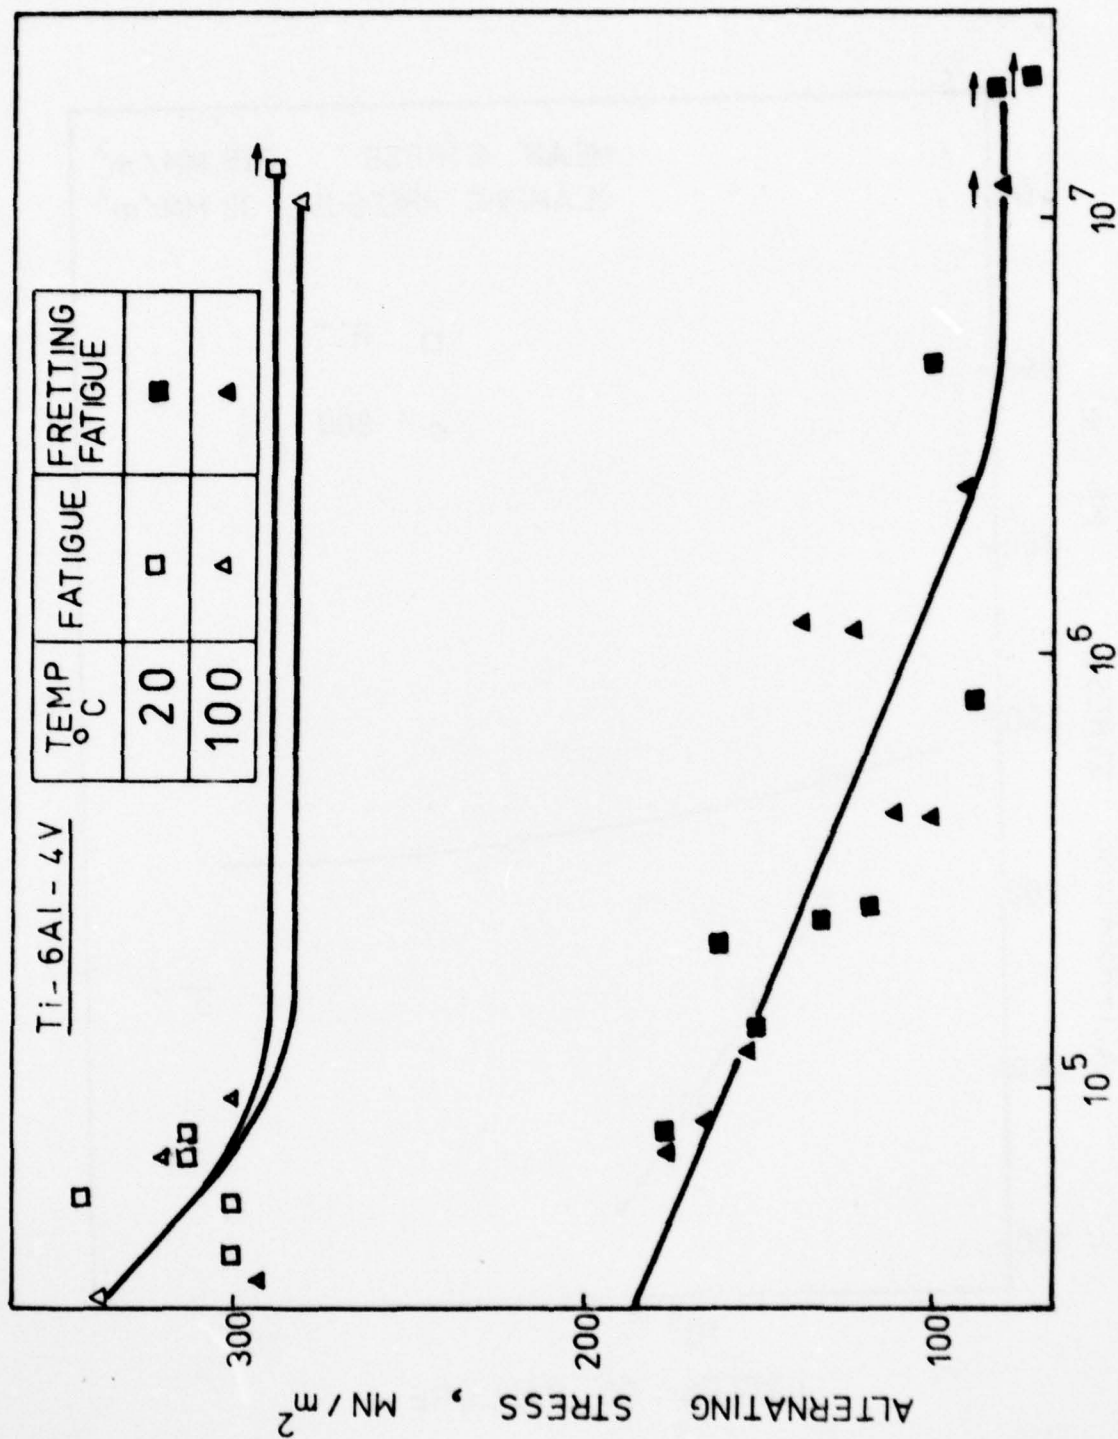
Fig. (29) FATIGUE AND FRETTING FATIGUE CURVES FOR Ti-ALLOY (AMMRC)

Fretting fatigue tests have been conducted on Ti-6Al-4V (AMMRC) in the as received condition at room temperature and 100 C. All specimens were tested at 400 MN/m² tensile mean stress and 32 MN/m² clamping stress. The obtained results are shown graphically in Figure 29. All the fretting fatigue results were somewhat scattered but appeared to lie on one curve. This leads to the conclusions that in the presence of fretting there is no distinction between the behaviour of this alloy at the two testing temperatures. The fretting fatigue strength at 10⁷ cycles is 400 ± 83 MN/m². These results agree reasonably closely with those obtained for Ti-6Al-4V (IMI 318), see Section 4.2.1.1.

Plain fatigue tests have been conducted on Ti-6Al-4V alloy (AMMRC) in the as received condition at room temperature and 100 C. All specimens were tested at 400 MN/m² tensile mean stress. The results obtained are shown graphically in Figure 29. These results reveal that there is no significant effect on the plain fatigue strength of the alloy as the temperature is raised from room temperature to 100 C. The plain fatigue strength at 10⁷ cycles at the two testing temperatures is very similar, namely 400 ± 290 MN/m² at room temperature and 400 ± 283 MN/m² at 100 C. The strength reduction factor at 100 C, based on the plain fatigue strength of the alloy at room temperature is 1.02, which is in comparatively good agreement with the values obtained for IMI 318 alloy, see Section 4.2.1.2.

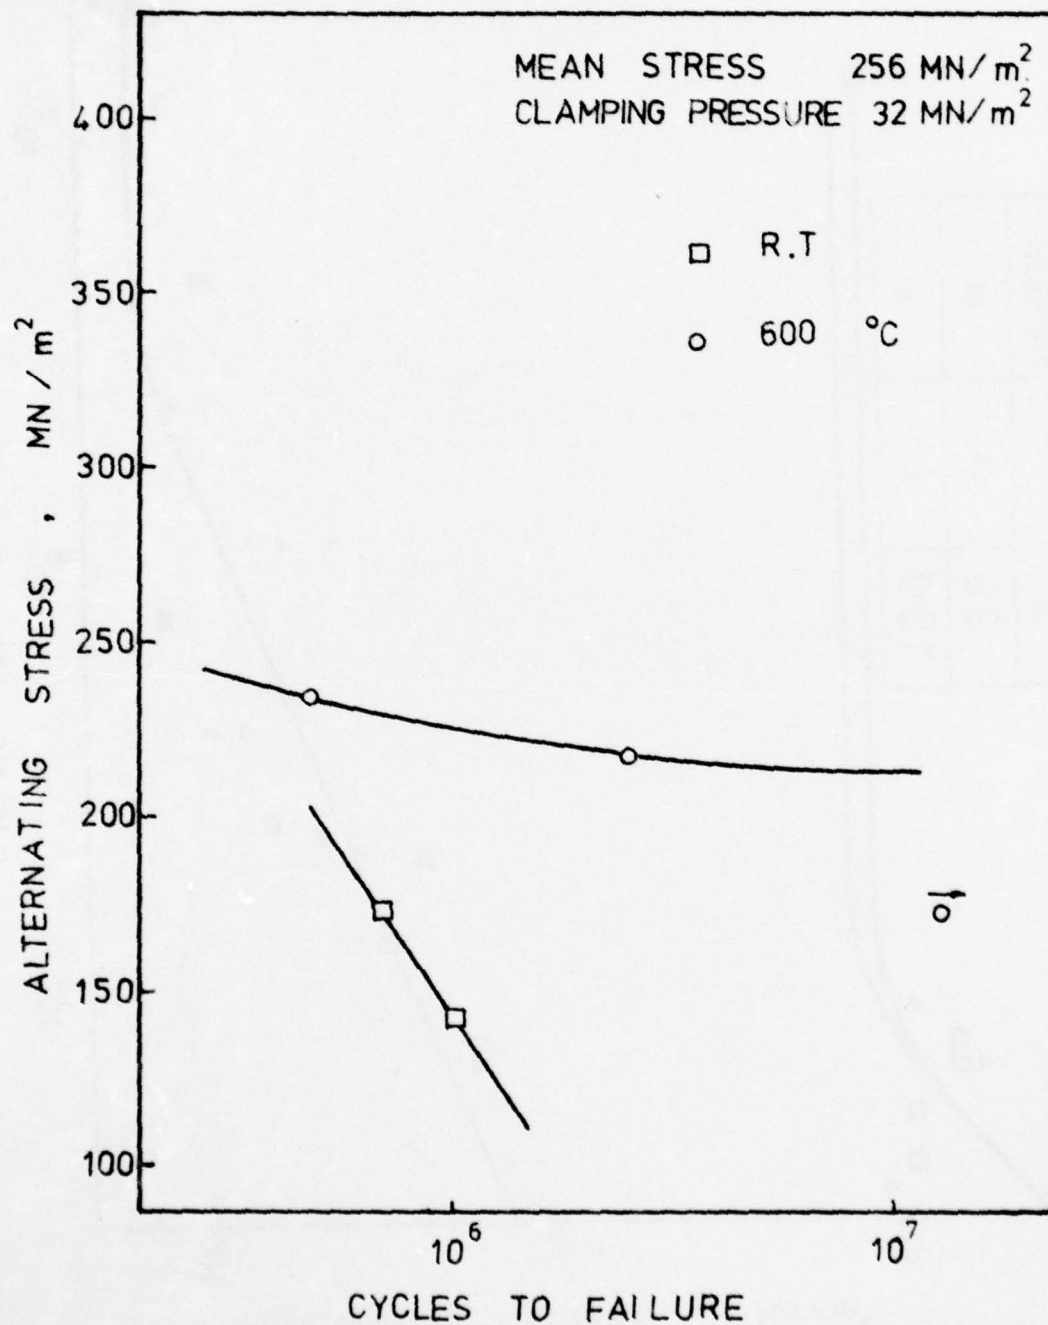
FIG.30 FRETTING FATIGUE CURVES OF ANNEALED INCONEL ALLOY 718 .

A few fretting fatigue tests were carried out on the material in its annealed condition at room temperature and 600 C as exploratory tests. The stressing conditions were a tensile mean stress of 256 MN/m² and a clamping stress of 32 MN/m². Few tests were conducted because this material is usually used in practice in the aged condition and also there was a shortage of material.

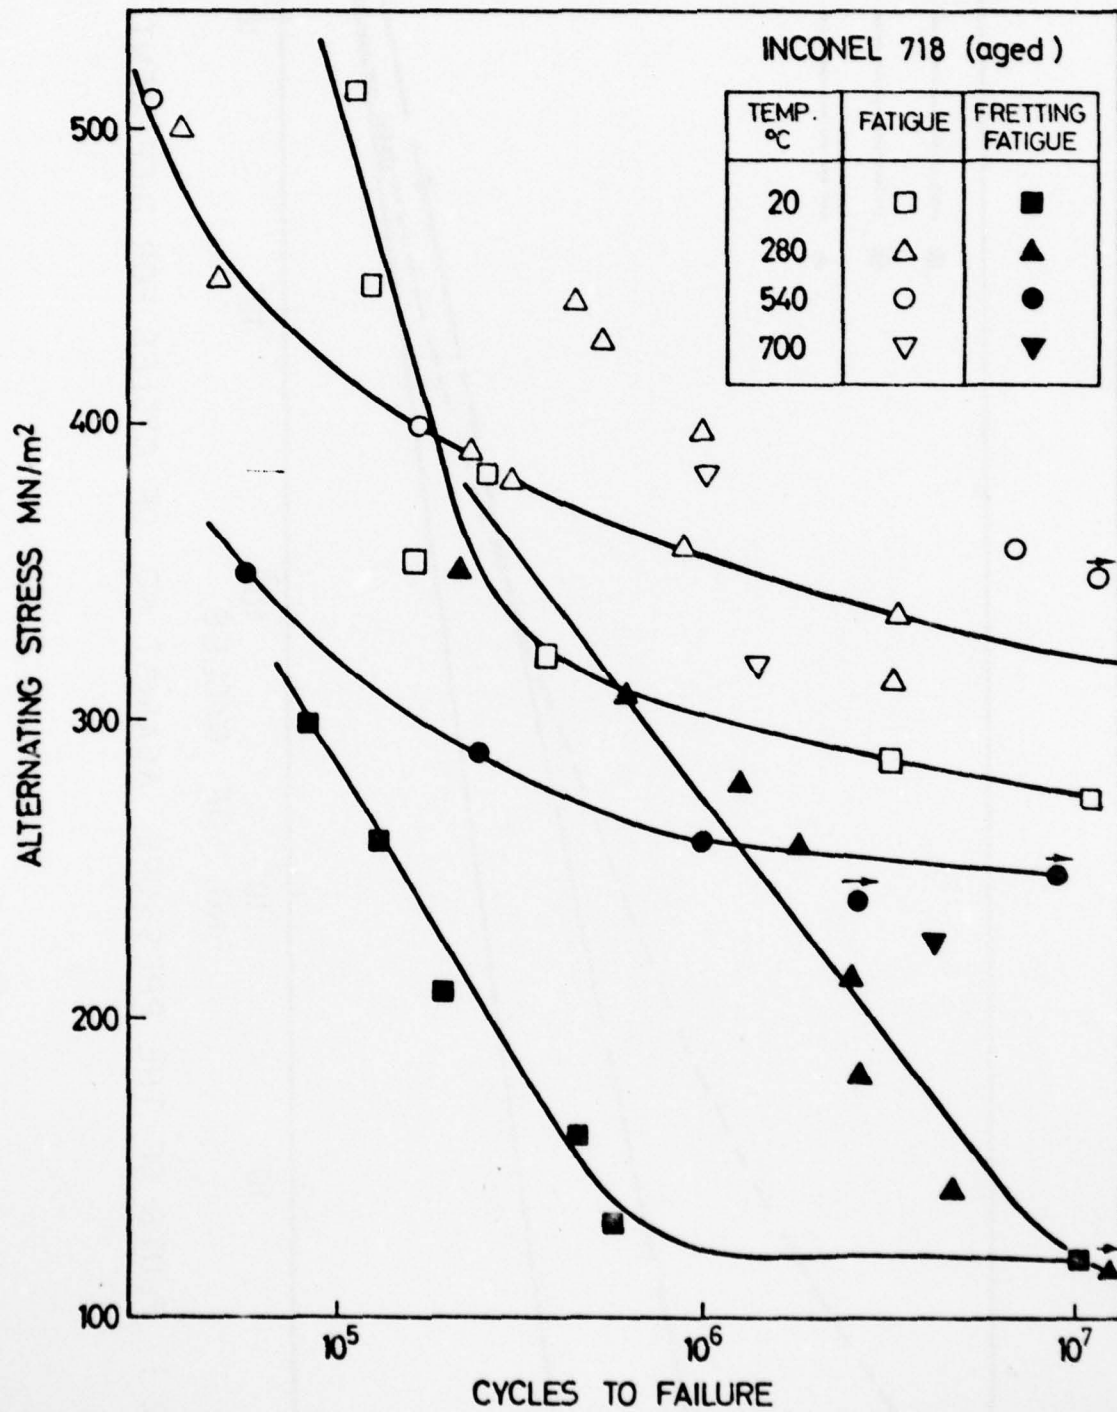
Fig.(31) FATIGUE AND FRETTING FATIGUE CURVES FOR INCONEL 718(AGED)

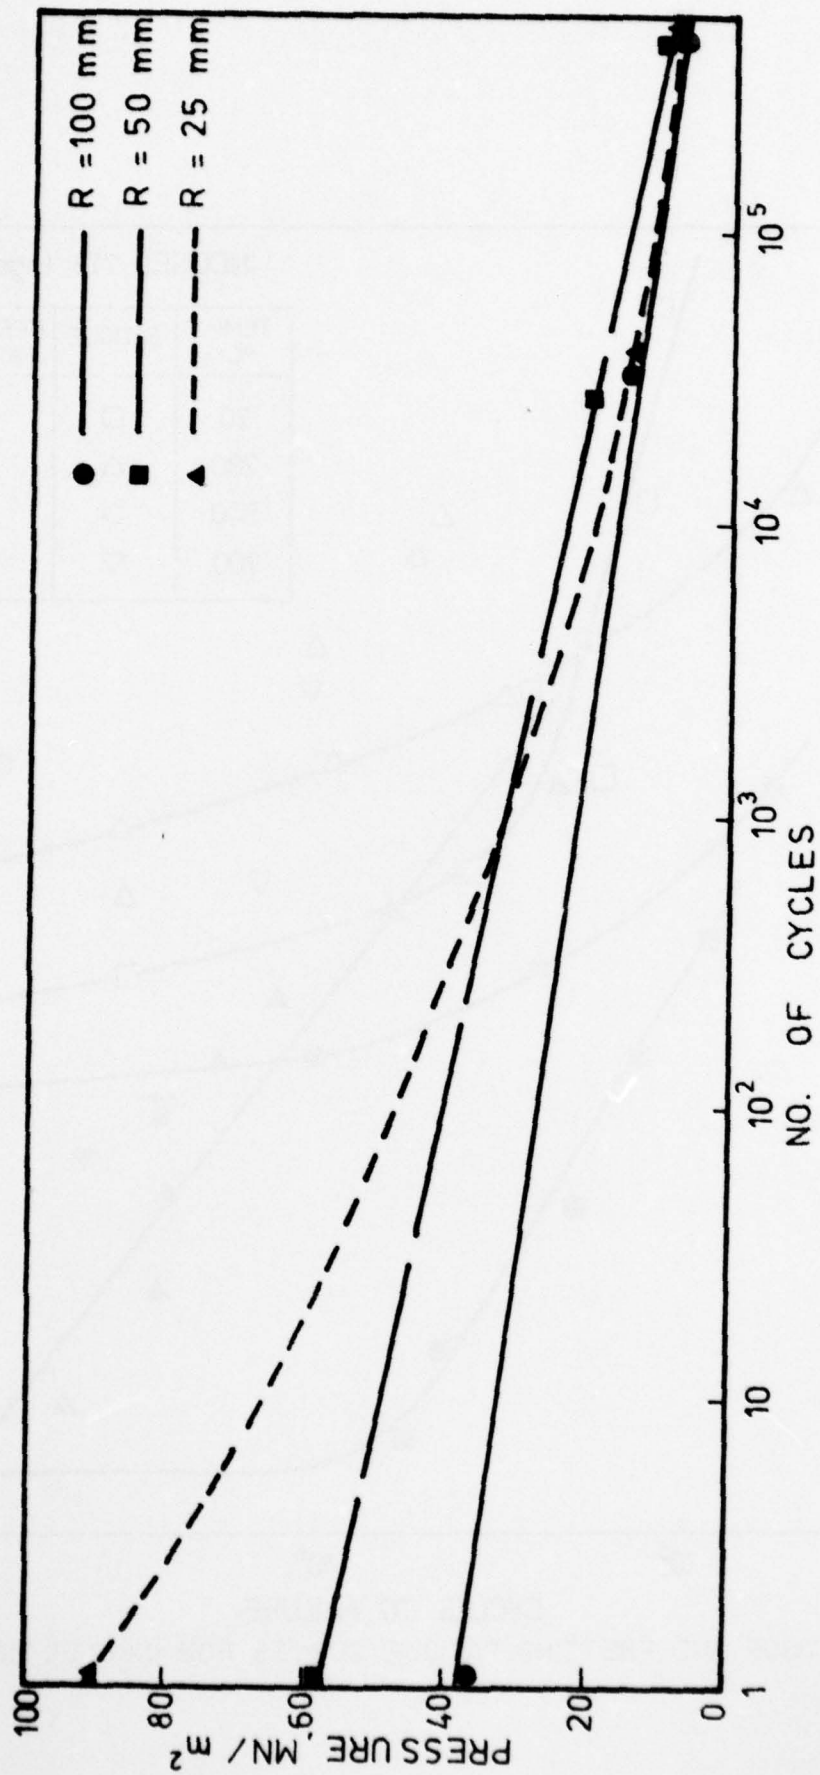
Fig.(32) PLOTS OF THE PRESSURE AGAINST NO OF CYCLES FOR DIFFERENT RADII .

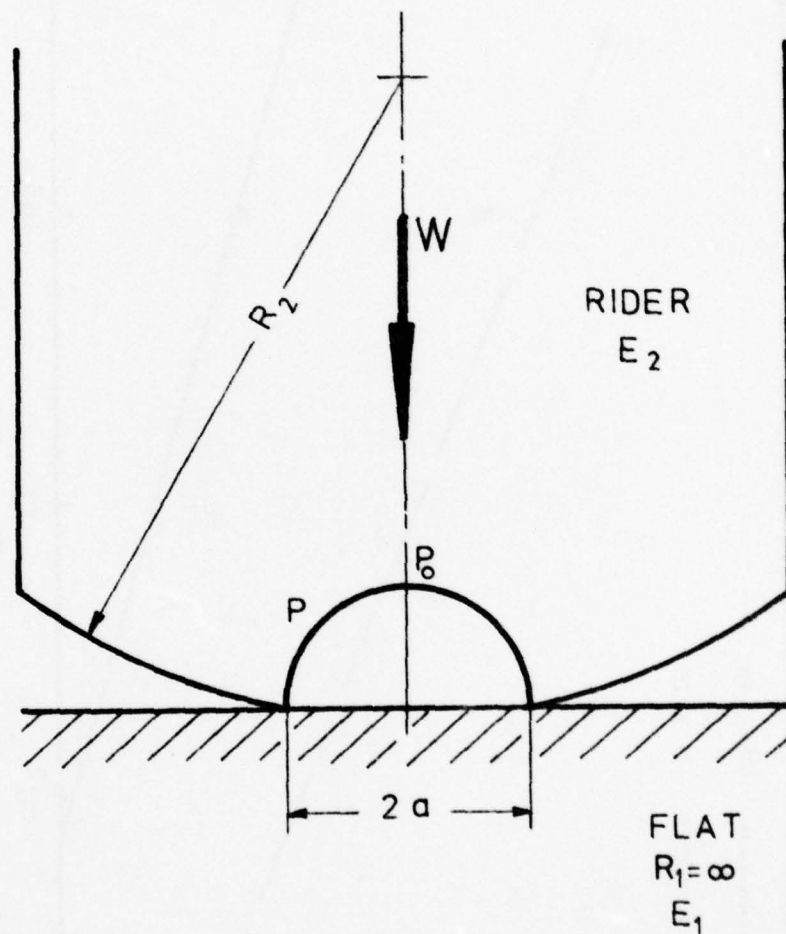
Fig. (33) CONTACT AREA BETWEEN
A RIDER AND A FLAT.

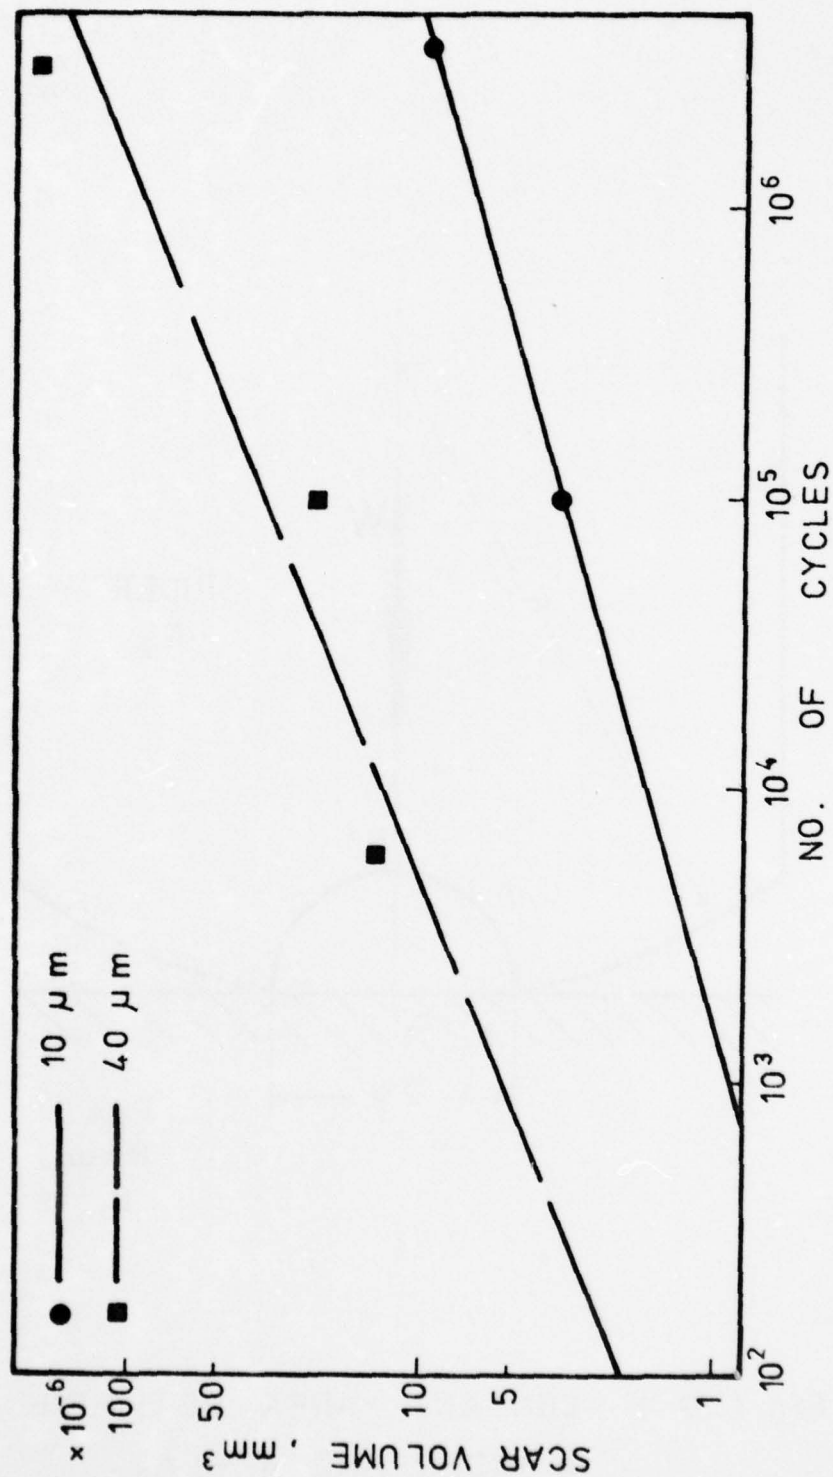
Fig. (34) PLOTS OF THE SCAR VOLUME AGAINST NO. OF CYCLES FOR
Ti-6AL-4V ALLOY (AMMRC) AT 20 °C .

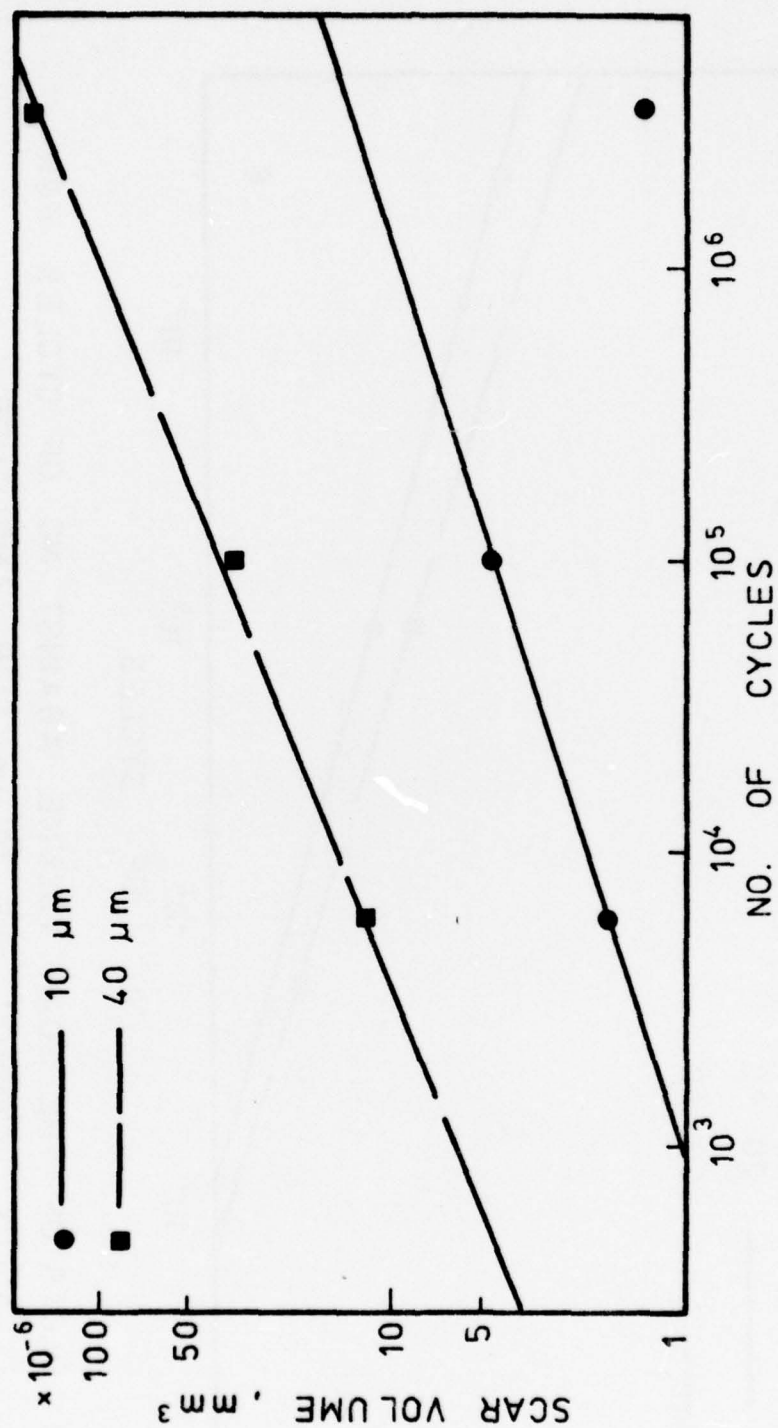
Fig. (35) PLOTS OF THE SCAR VOLUME AGAINST NO. OF CYCLES FOR
Ti - ALLOY (AMMRC) AT 100 °C.

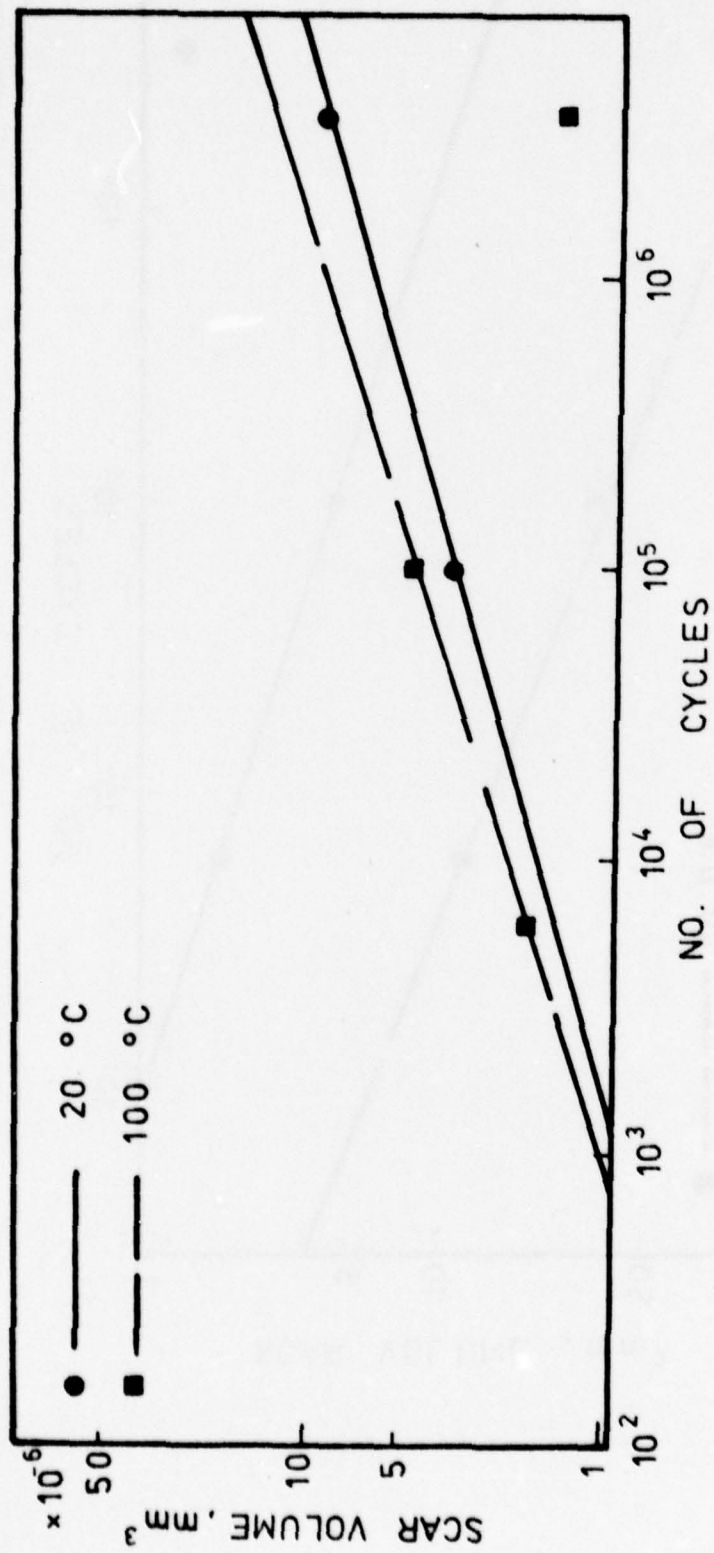
Fig.(36) PLOTS OF THE SCAR VOLUME AGAINST NO. OF CYCLES FOR
Ti-ALLOY (AMMRC) AT 10 μ m SLIP AMPLITUDE .
